MassDEP RTN 3-23246

# Phase V Status Report No. 6 and Remedial Monitoring Report No. 21

50 Tufts Street, Somerville, Massachusetts

August 1, 2014

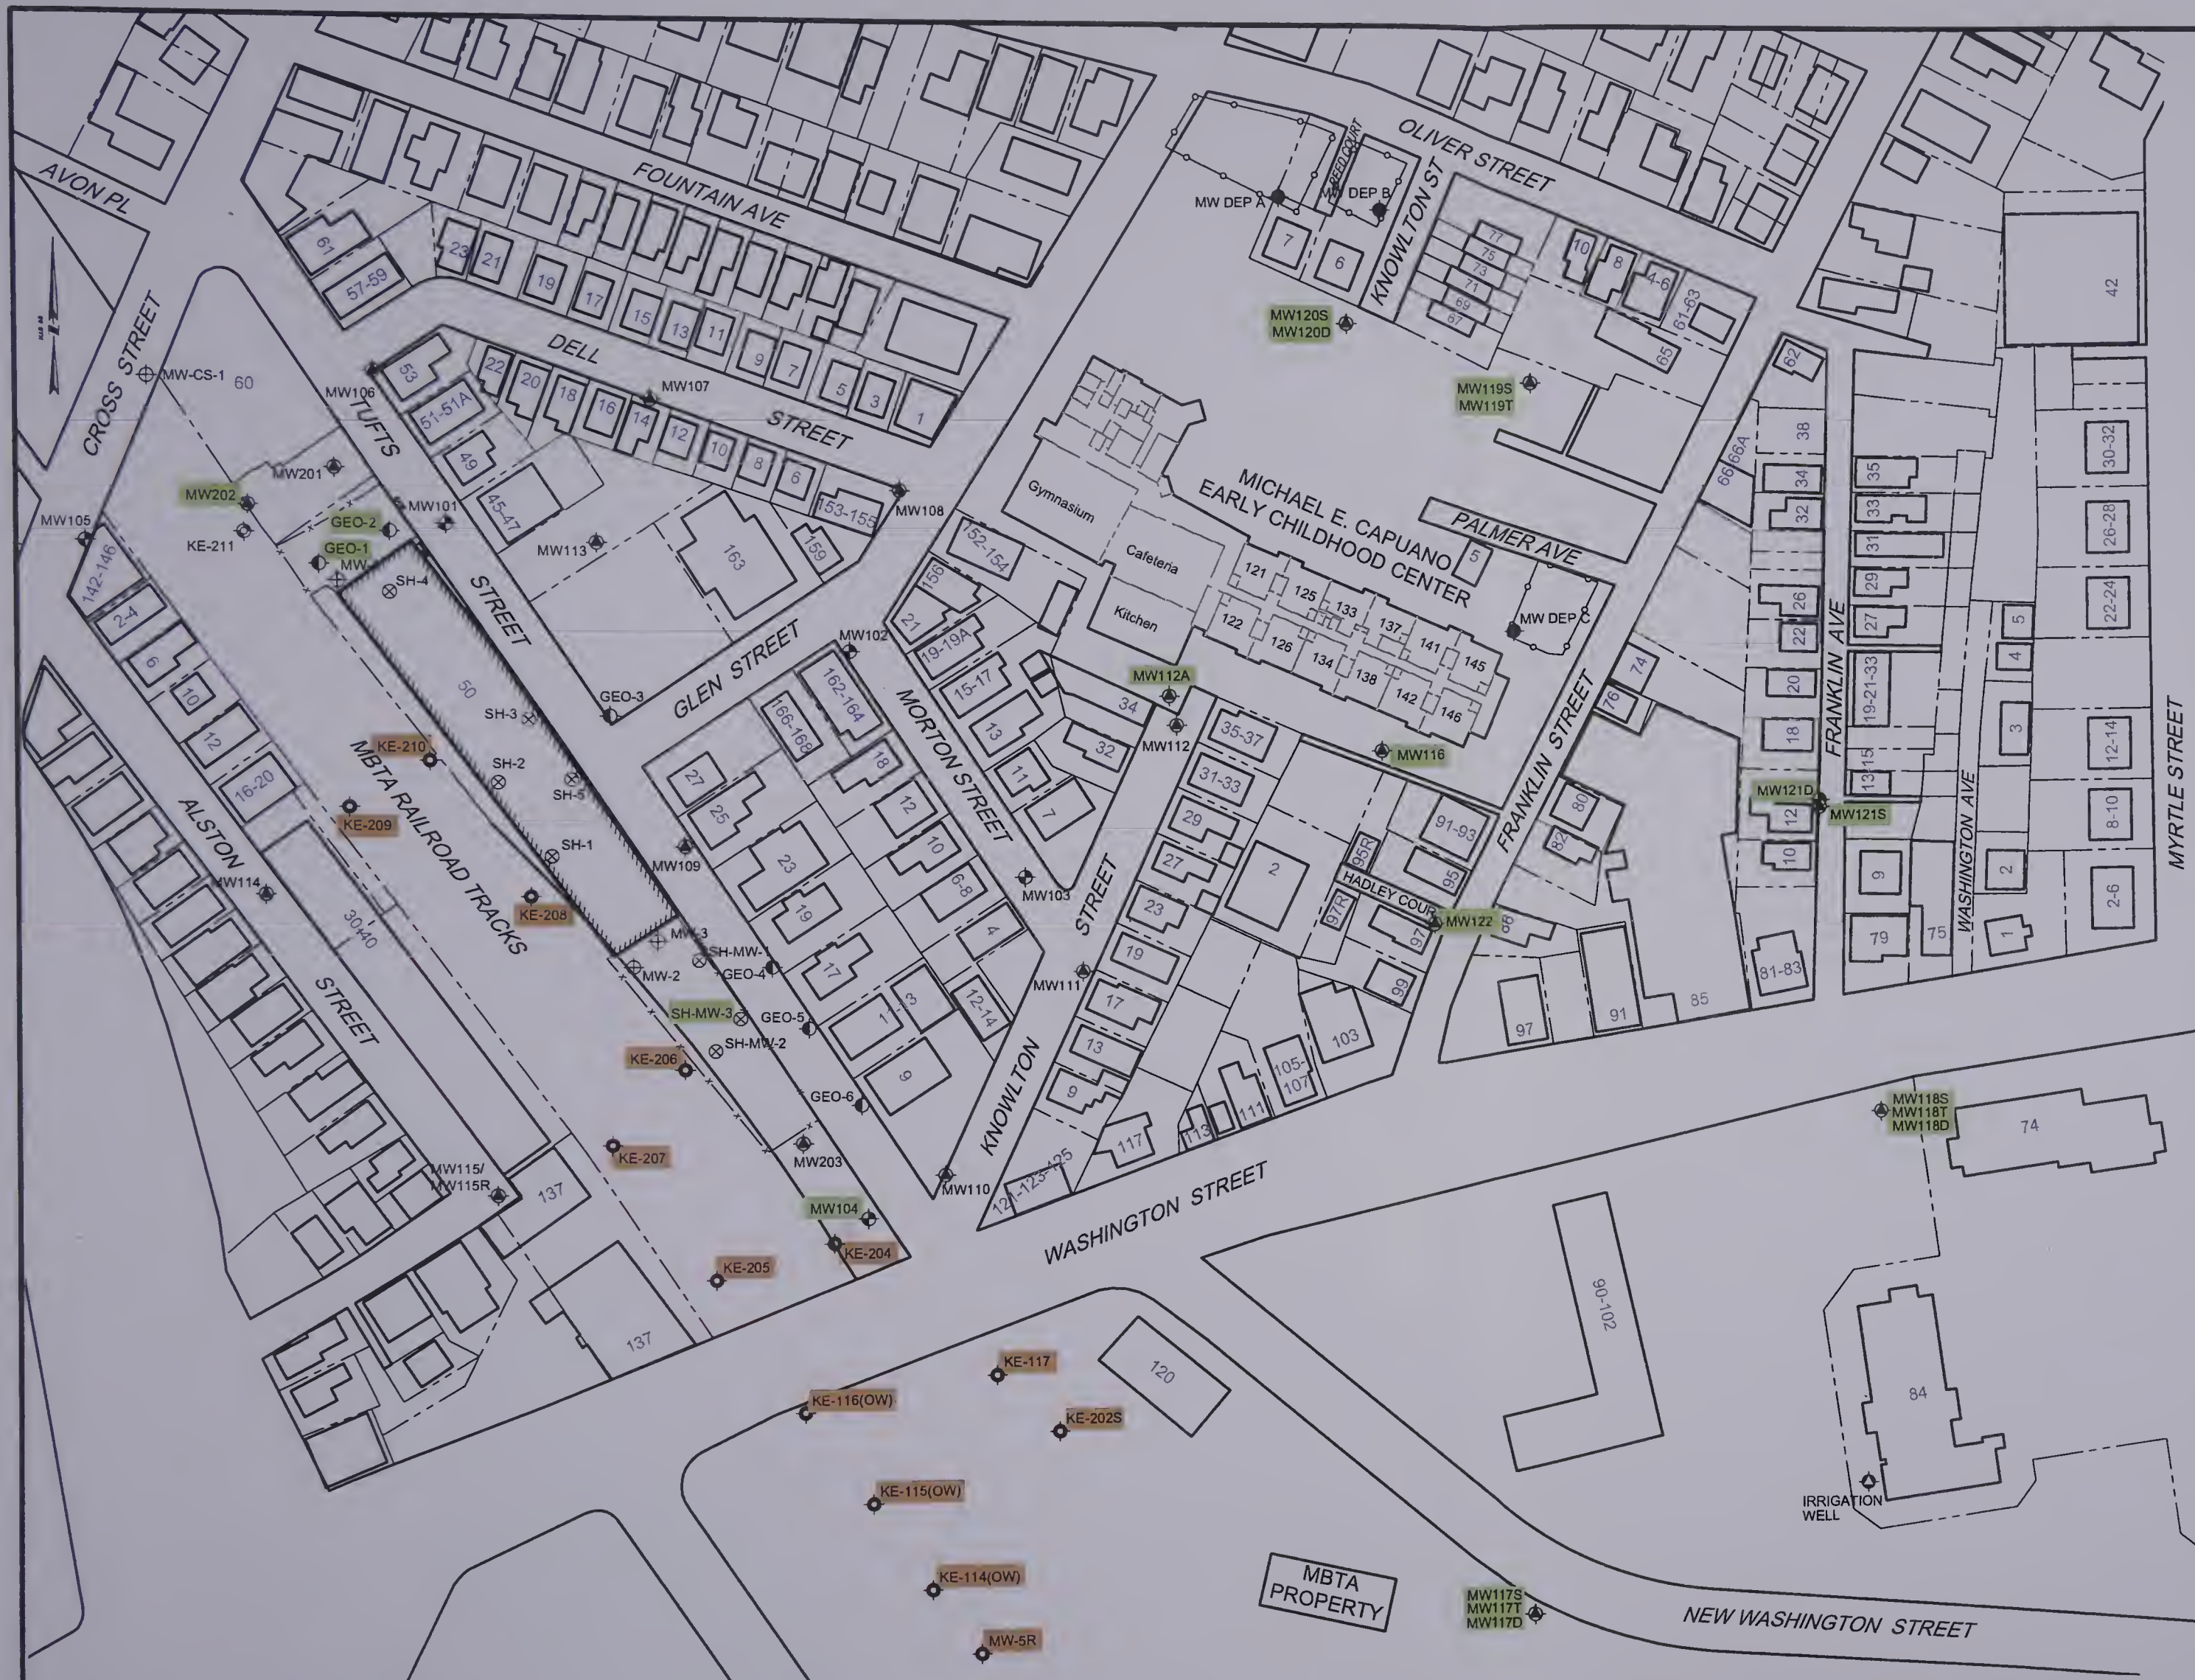
MONITORING WELL  
LOCATIONS  
Project 04516-3 August 2014 Fig. 2-1

- LEGEND:**
- BORING BY KLEINFELDER, MARCH 2014 AND APRIL 2014
  - MONITORING WELL BY KLEINFELDER, SEPTEMBER 2012, MARCH 2014, AND APRIL 2014
  - MONITORING WELL WITH SOIL VAPOR SAMPLE PORT INSTALLED BY GEI, JANUARY 2007 - JANUARY 2008
  - MONITORING WELL INSTALLED BY SANBORN HEAD ASSOCIATES, 2002
  - MONITORING WELL INSTALLED BY GEOINSIGHT, JUNE 2004
  - MONITORING WELL INSTALLED BY GEI, MAY 2006
  - DRIVEN POINT MONITORING WELL INSTALLED BY MADEP, MAY 2007
  - MONITORING WELL INSTALLED PREVIOUSLY, DATE UNKNOWN
  - PREVIOUSLY INSTALLED IRRIGATION WELL
  - CHAIN LINK FENCE
  - 138 ROOM NUMBER AT CAPUANO SCHOOL
  - BOUNDARY OF COMMUNITY GARDENS
  - 84 STREET ADDRESS
  - MONITORING WELL SAMPLED BY GEI DURING THIS REPORTING PERIOD
  - MONITORING WELL SAMPLED BY KLEINFELDER DURING THIS REPORTING PERIOD

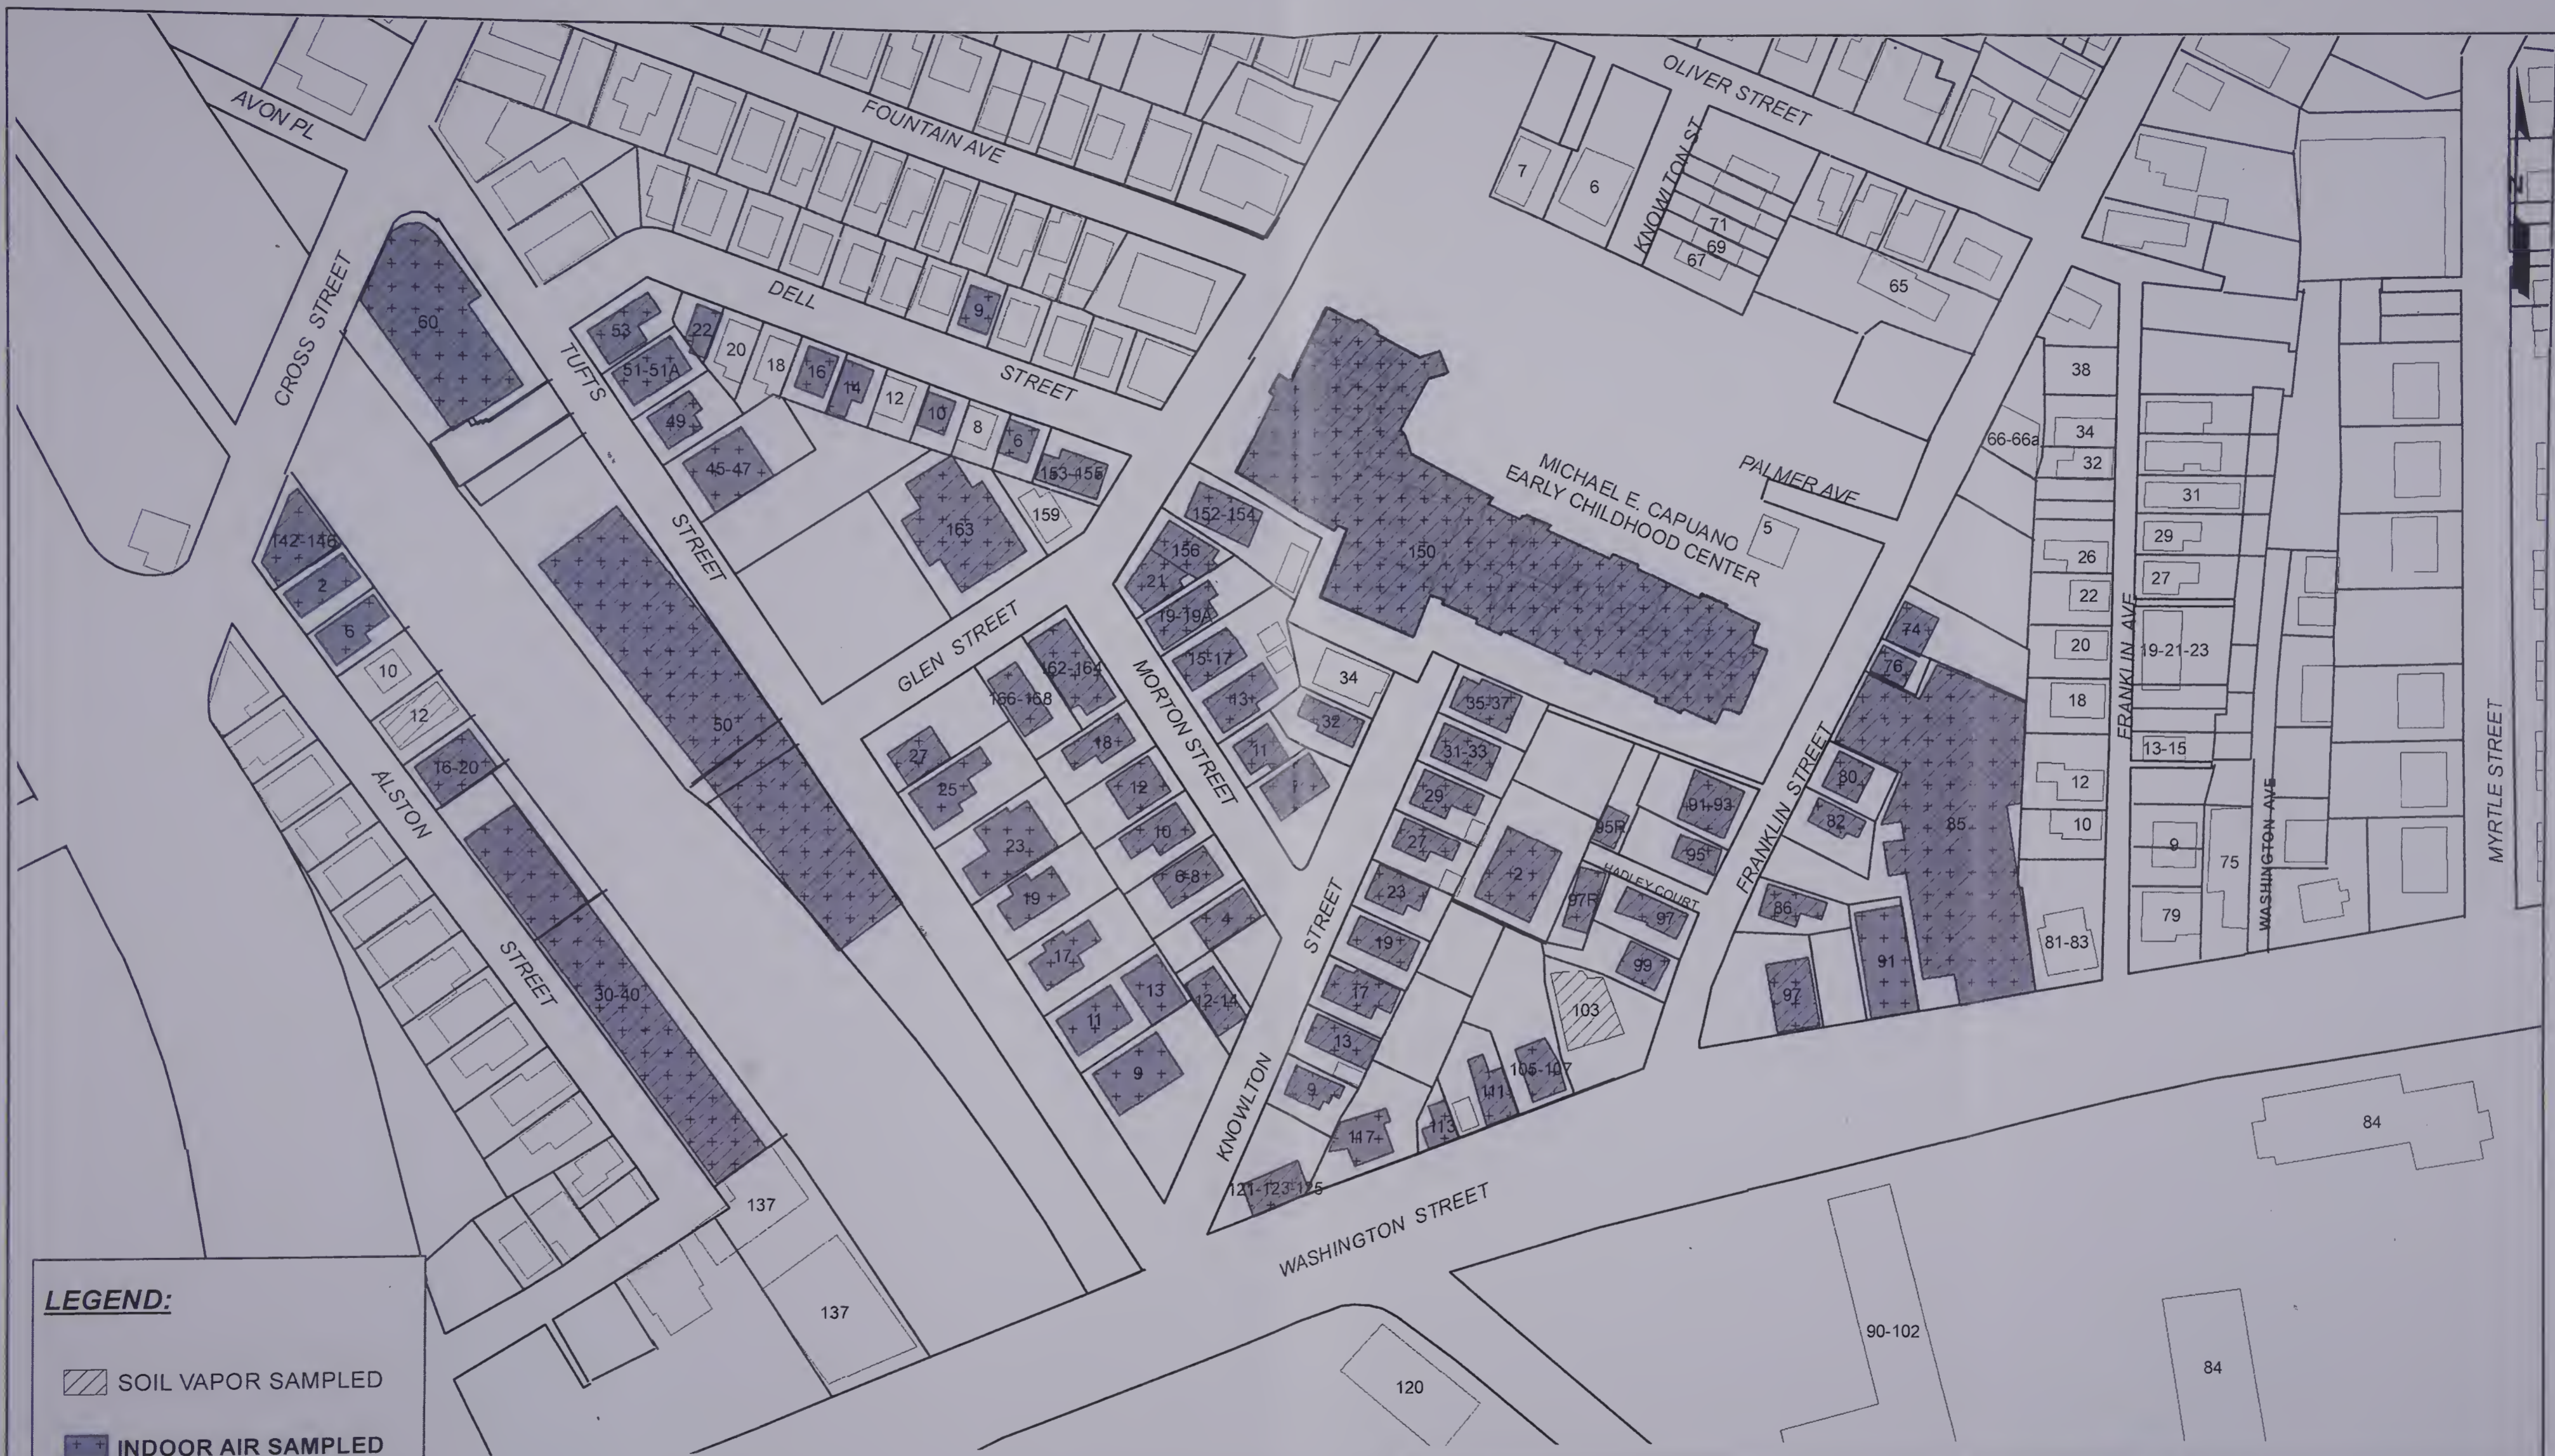
GEI evaluated the groundwater chemical testing results collected during MNA activities to update and supplement the plume stability monitoring and natural attenuation evaluation. During this reporting period, annual groundwater sampling was conducted by GEI at 20 monitoring wells shown in Fig. 2-1.

period are shown in Fig. 2-1. The laboratory data reports associated with the April to June 2014 groundwater testing are in Appendix D.

Between February and April 2014 Kleinfelder conducted groundwater sampling at 14 monitoring wells (KE-114[OW] through KE-117[OW], MW-5R, and KE-202-WS through KE-210-WS). Groundwater samples were submitted to Con-Test for VOC analyses. The sample results are summarized in Table 2-4. The laboratory data reports associated with the groundwater testing are in Appendix D. Monitoring well locations and the monitoring wells sampled by Kleinfelder during this reporting period are shown in Fig. 2-1.

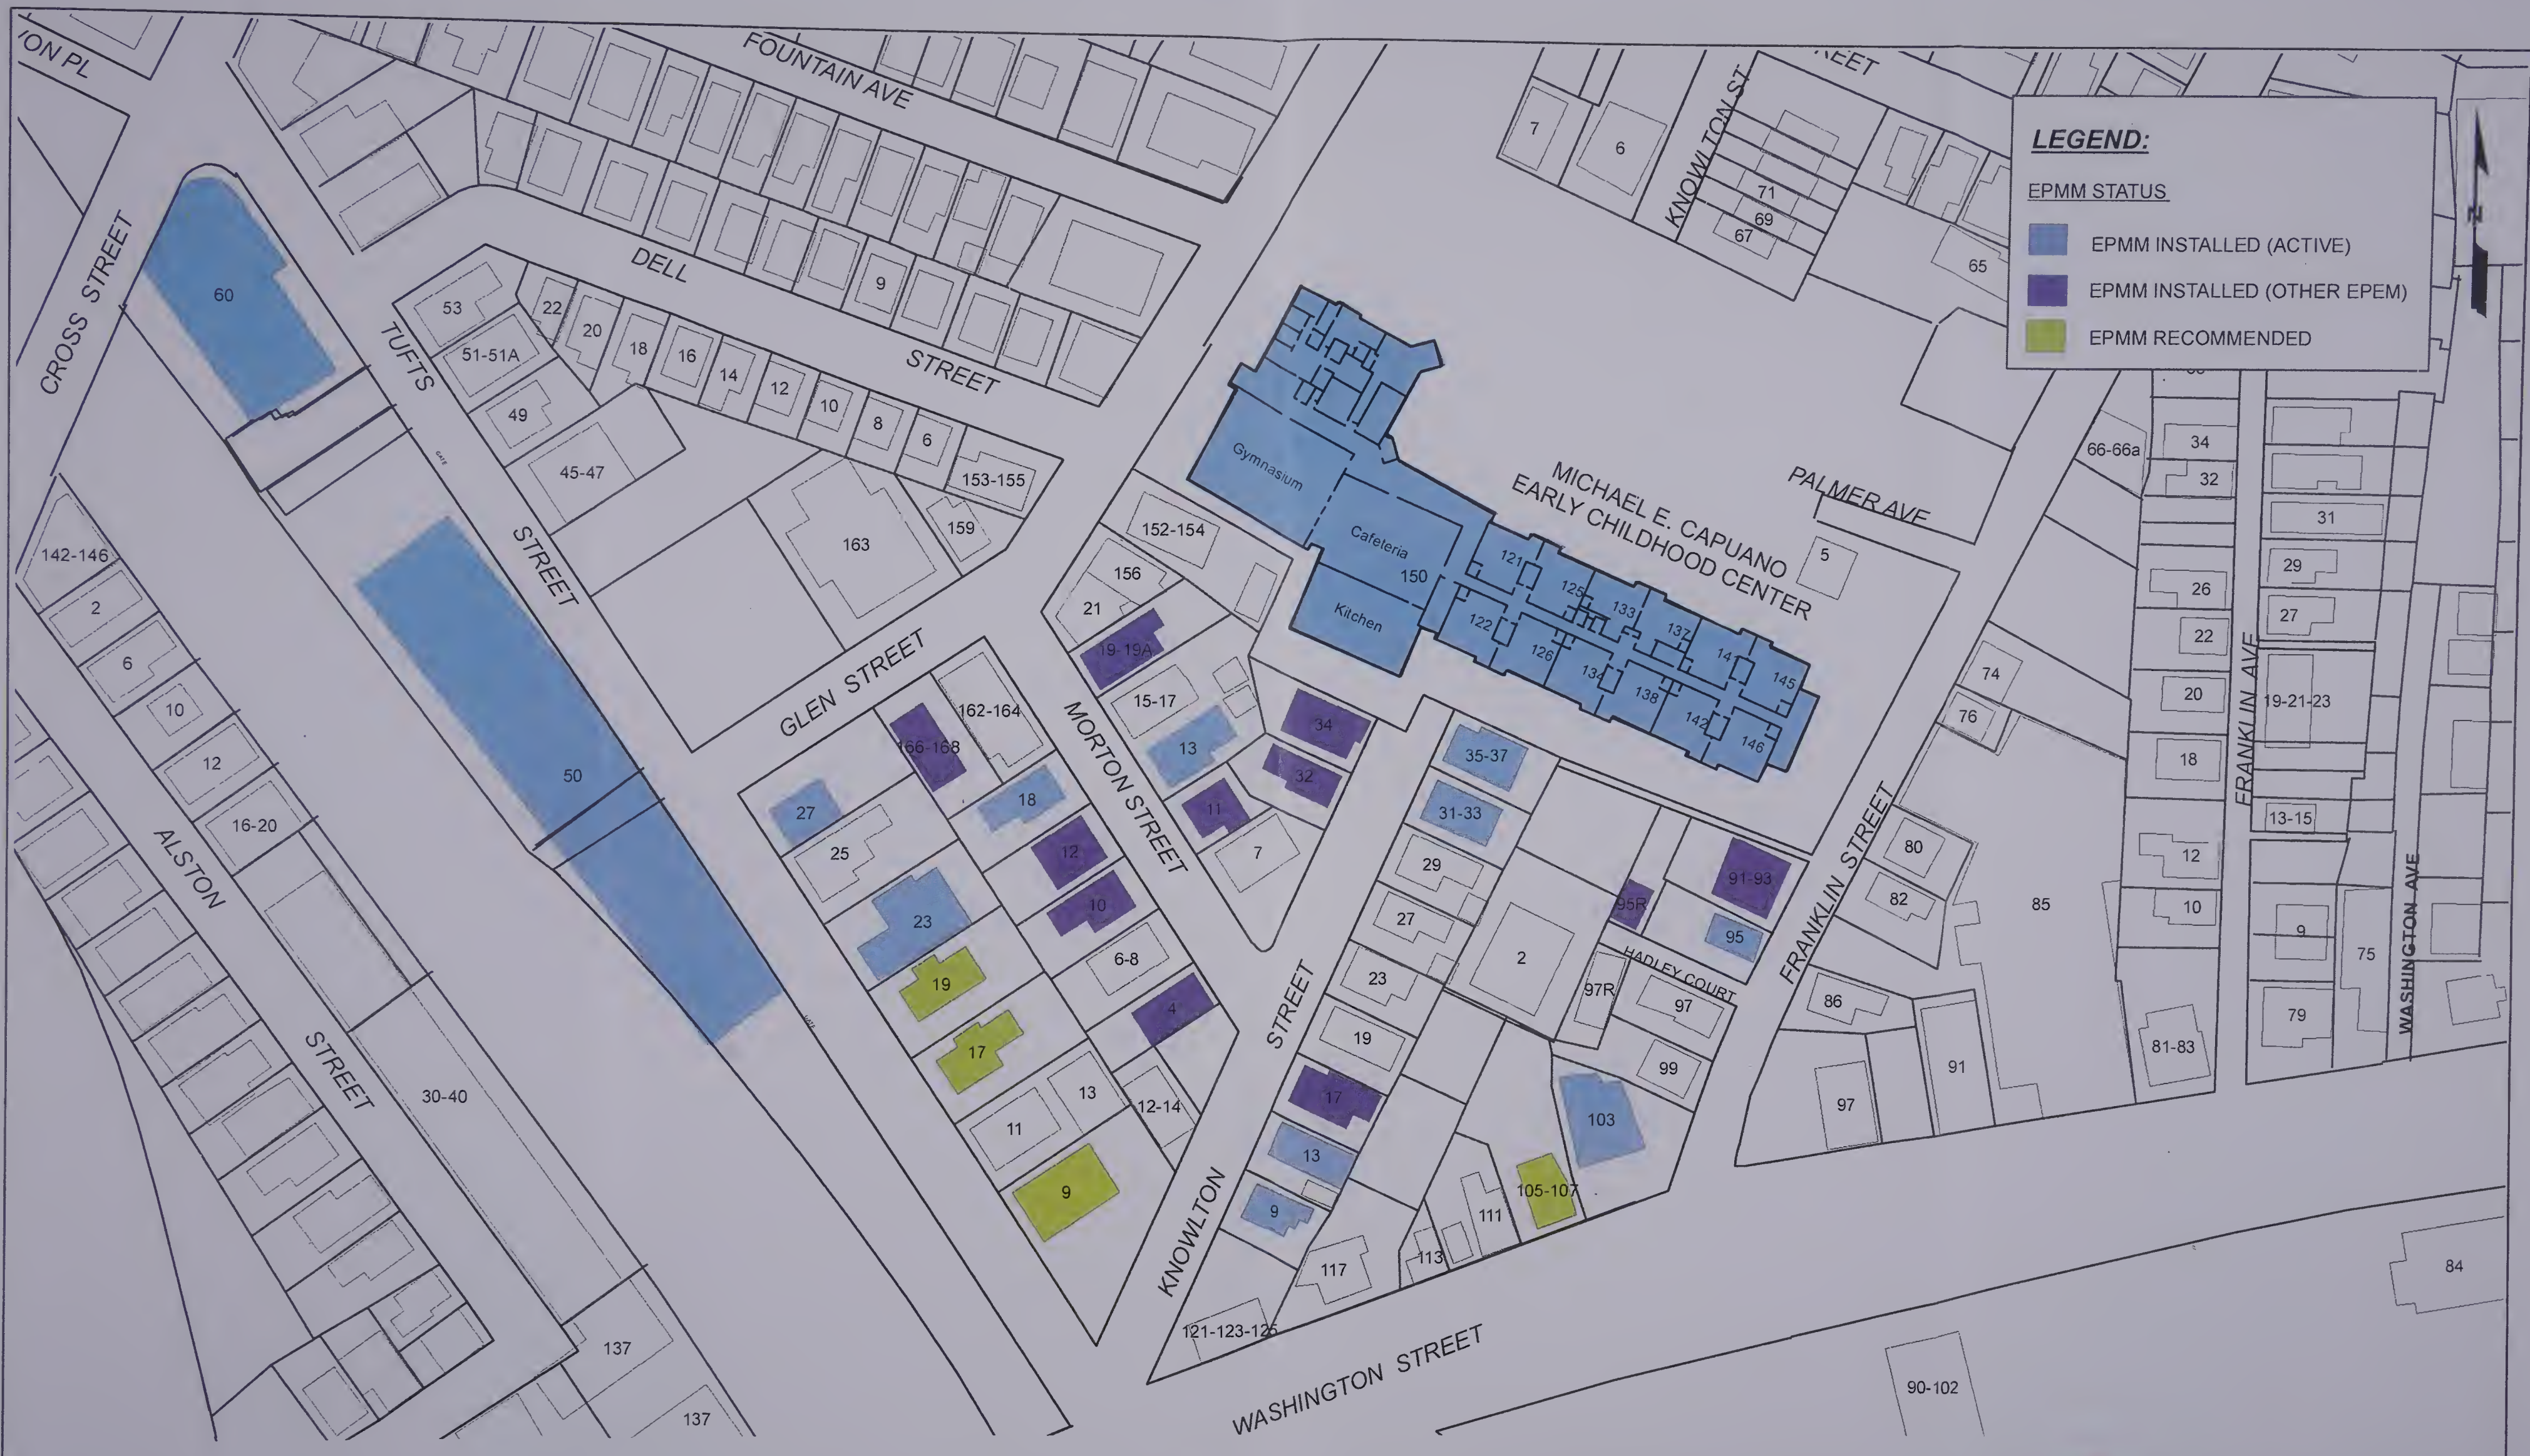
Fig. 4-1

<b>EPMM INSTALLATION PROGRESS</b>
UniFirst Corporation Wilmington, Massachusetts	Project 04516-3	August 2014

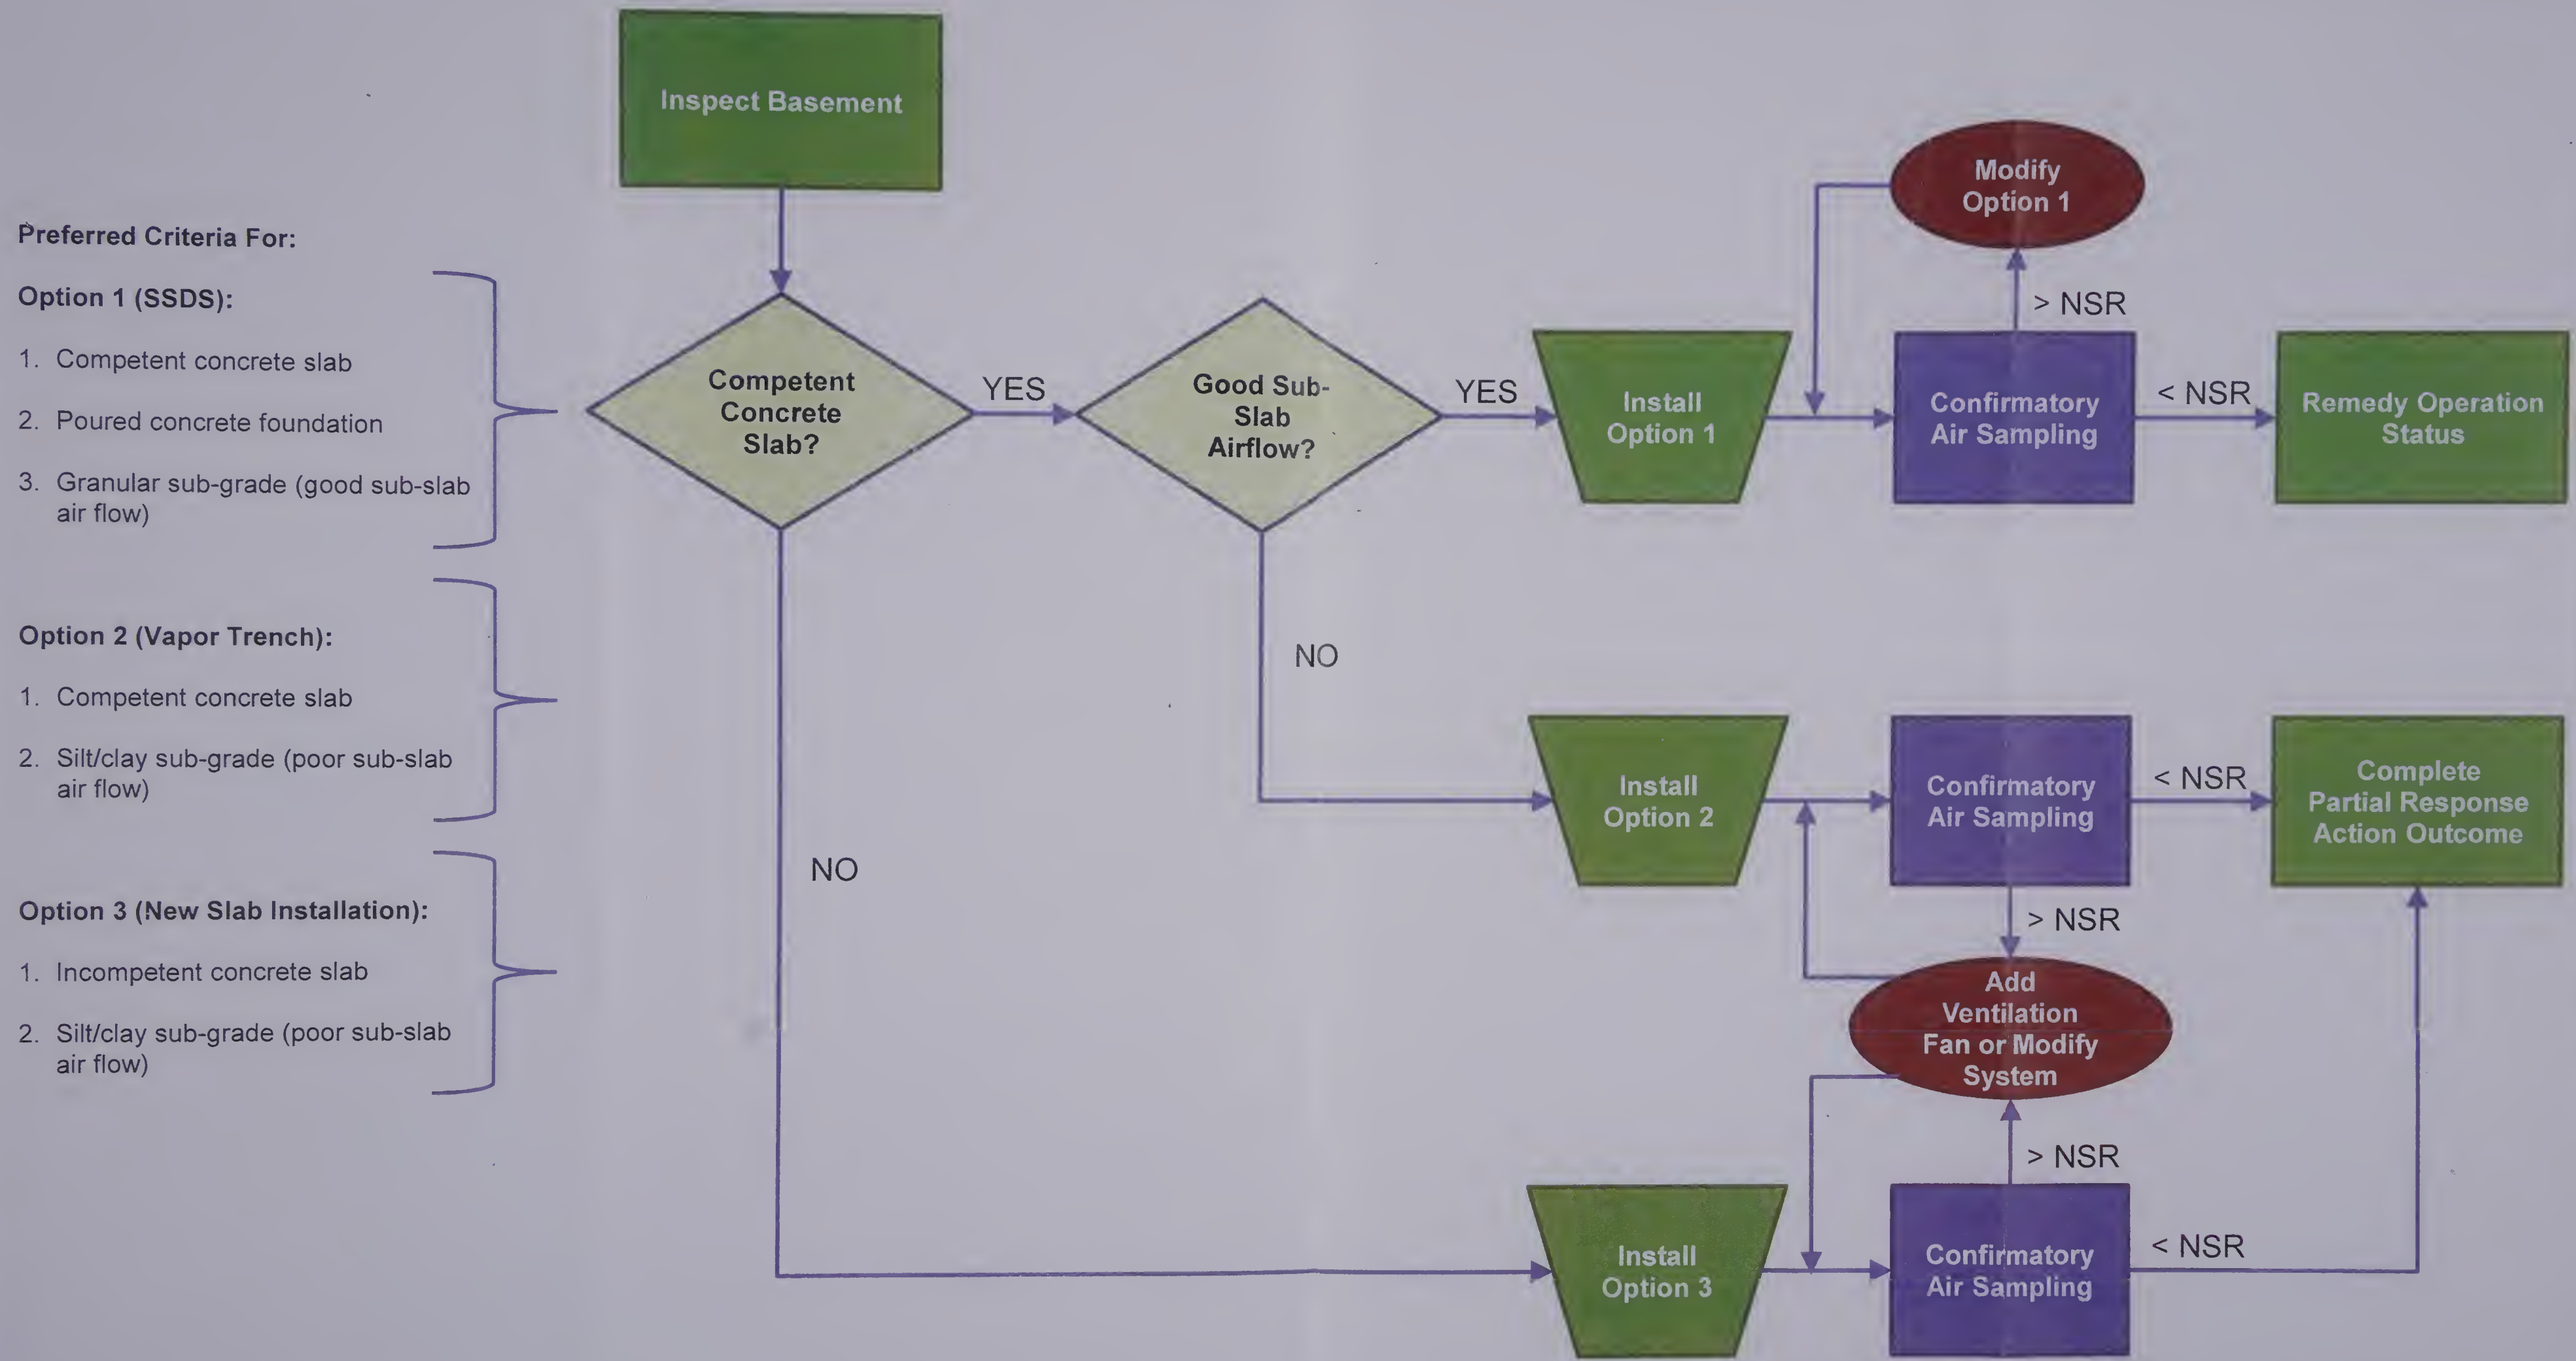
EPMM MITIGATION FLOW CHART
UniFirst Corporation Wilmington, Massachusetts	Project 04516-3	August 2014 <span style="float: right;">Fig. 4-2</span>

**Option 1 (SSDS):**

- Option 2 – Vapor Trench: The vapor trench option consists of a sub-slab venting system installed in a shallow trench around the interior basement perimeter, cement stucco applied to the walls, and an epoxy vapor barrier applied to the slab and stucco walls. The trench is backfilled with crushed stone and finished with approximately three inches of new concrete to meet the existing slab surface. This option is installed in buildings with poor sub-slab air flow, a competent concrete slab, and a fieldstone and/or brick foundation. Sub-slab vapors are vented through a piping network that exits the building envelope at the sill elevation and terminates above the eave line of the roof.

- Option 3 – New Slab: The new slab installation option consists of installing a new concrete slab, a sub-slab vapor barrier, and a floor venting system; applying cement stucco to the walls; and applying an epoxy vapor barrier to the new slab and stucco walls. This option is installed in buildings with poor sub-slab air flow, an incompetent concrete slab, and a fieldstone and/or brick foundation. As with Option 2, sub-slab vapors are vented through a piping network that exits the building envelope at the sill elevation and terminates above the eave line of the roof.

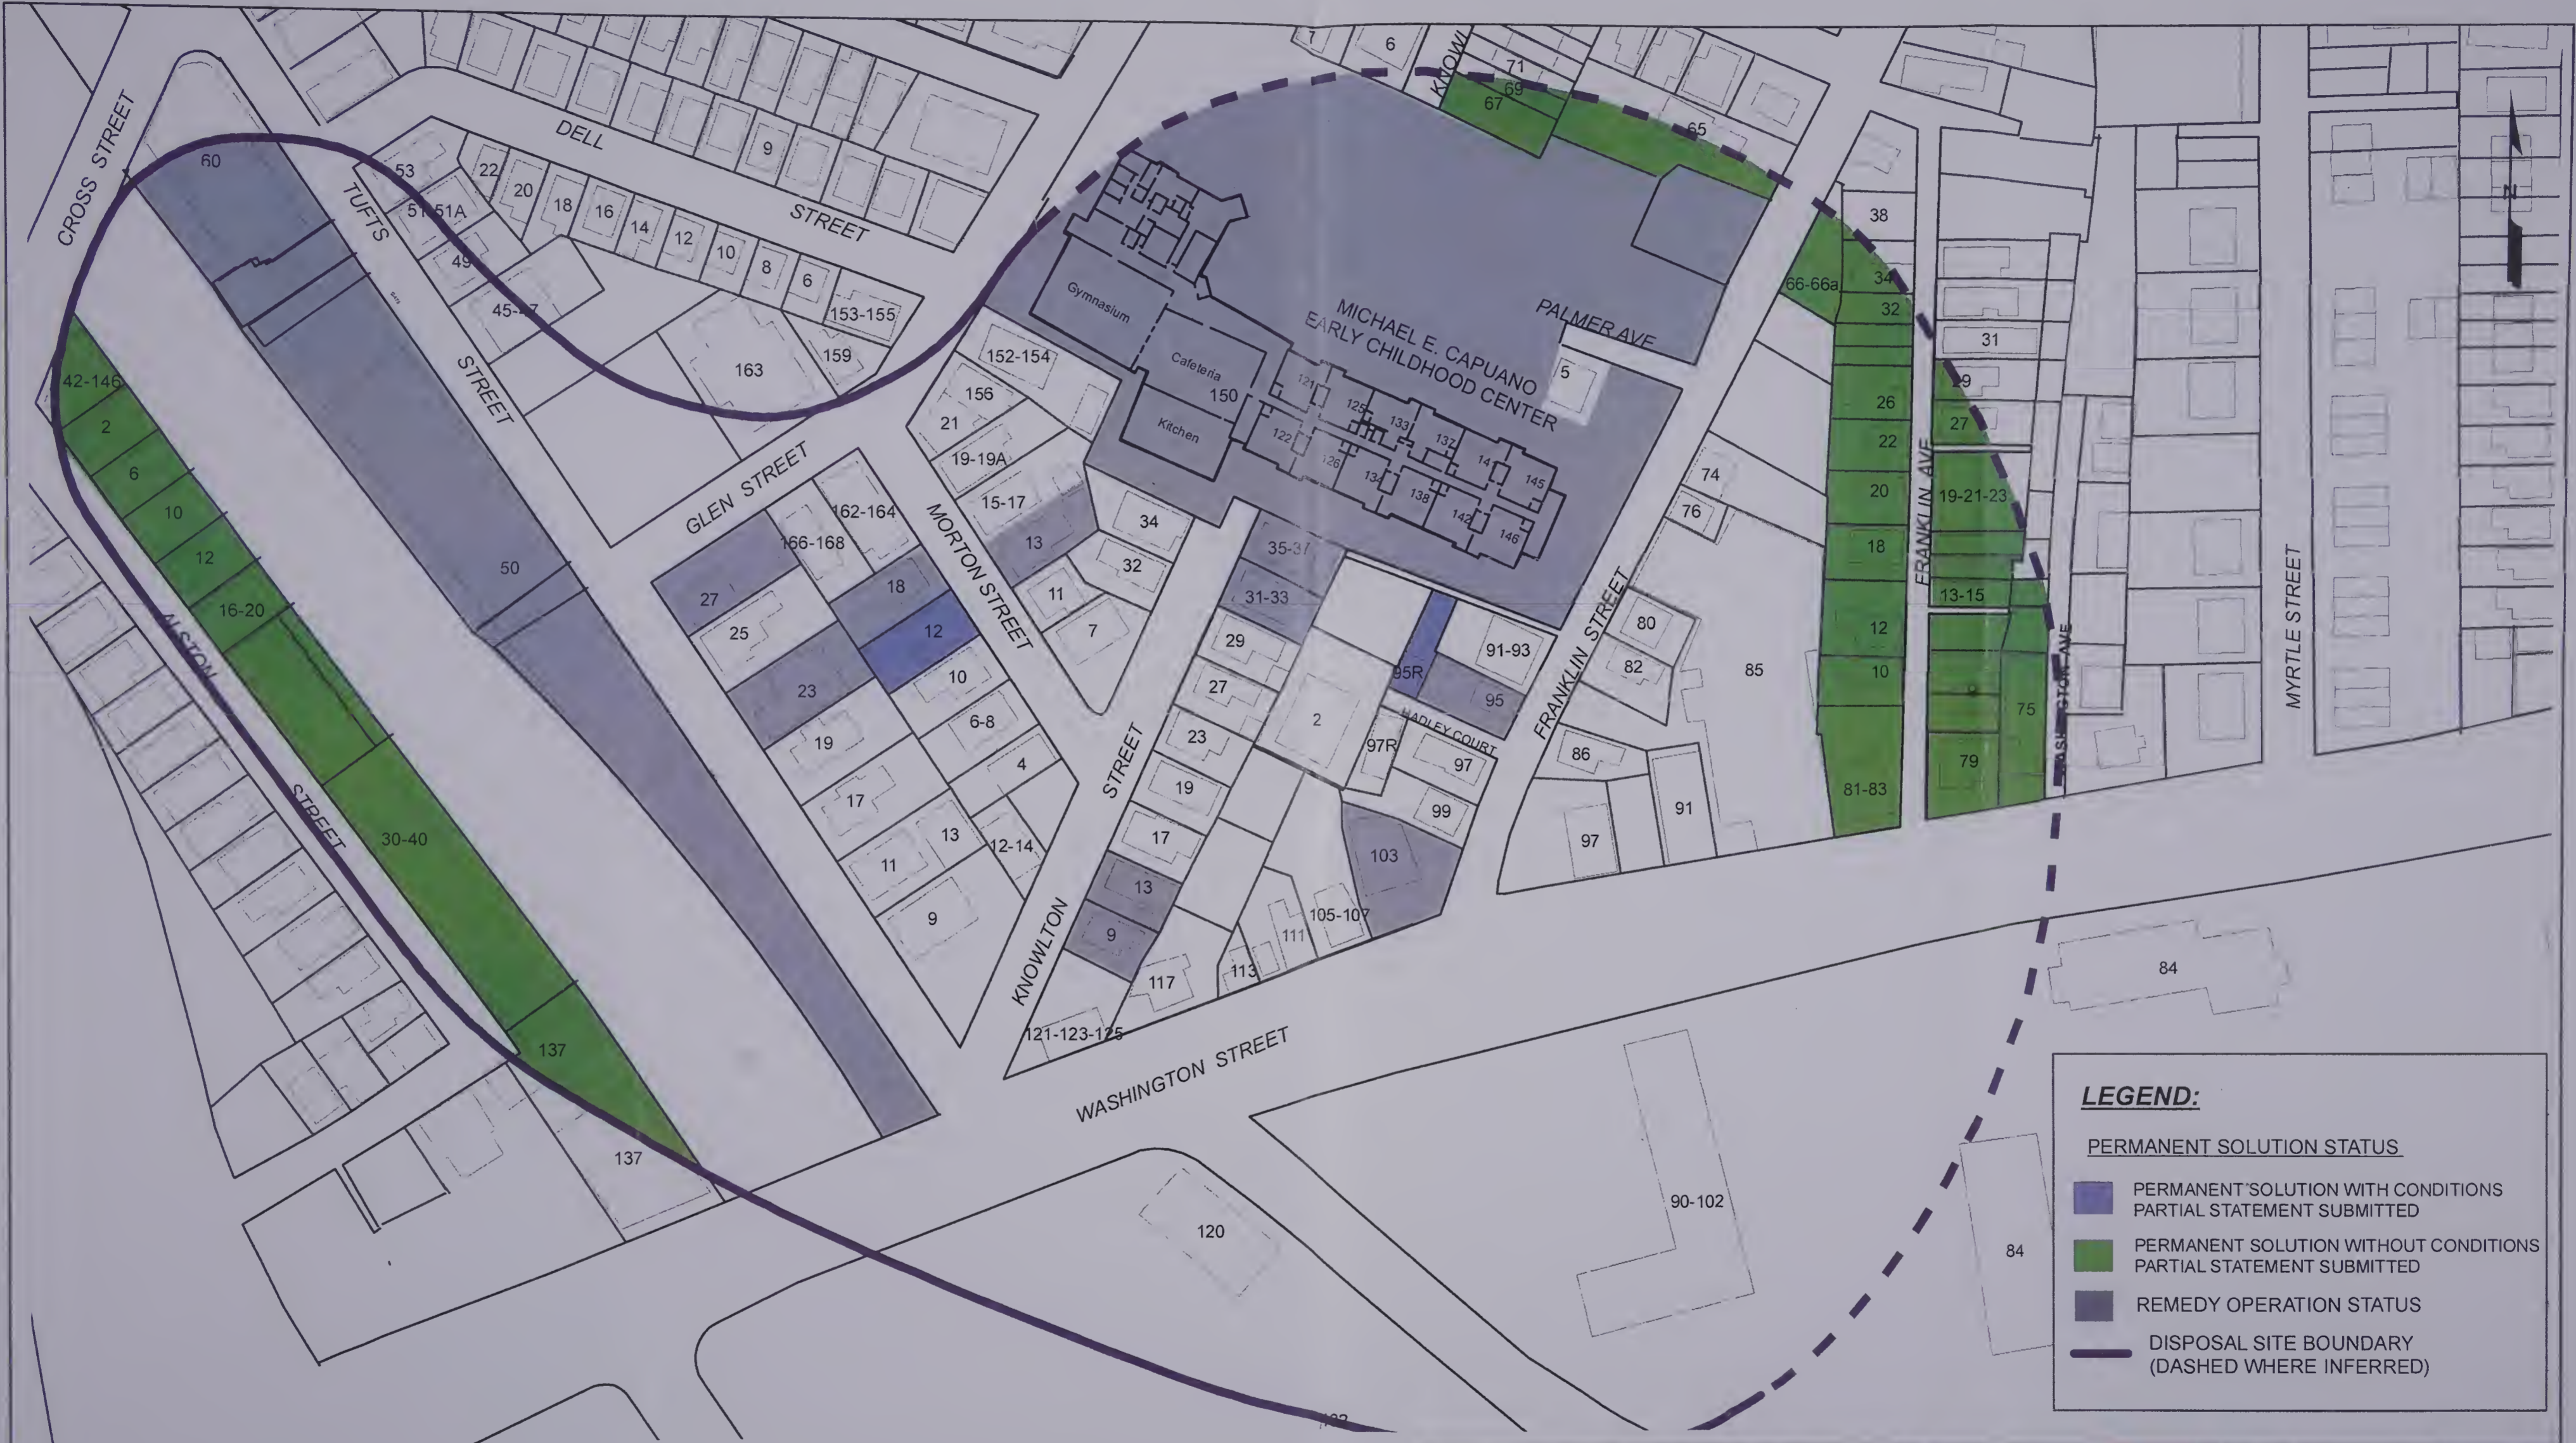
Project 04516-3 August 2014 Fig. 4-3

**PERMANENT SOLUTION STATUS**
